Re: Tucson Speedway Historical Houses Relocation
926 N 2nd Ave, Tucson, AZ 85719
CORE Job No. 24-02-006

This correspondence is submitted to document final roof color selections for the subject properties and to request review of limited exterior material and window modifications for House 818 only, as discussed during our on-site walk conducted on January 22, 2026.

TUCSON SPEEDWAY HISTORICAL HOUSES RELOCATION

818 - RELO
ELEVATIONS

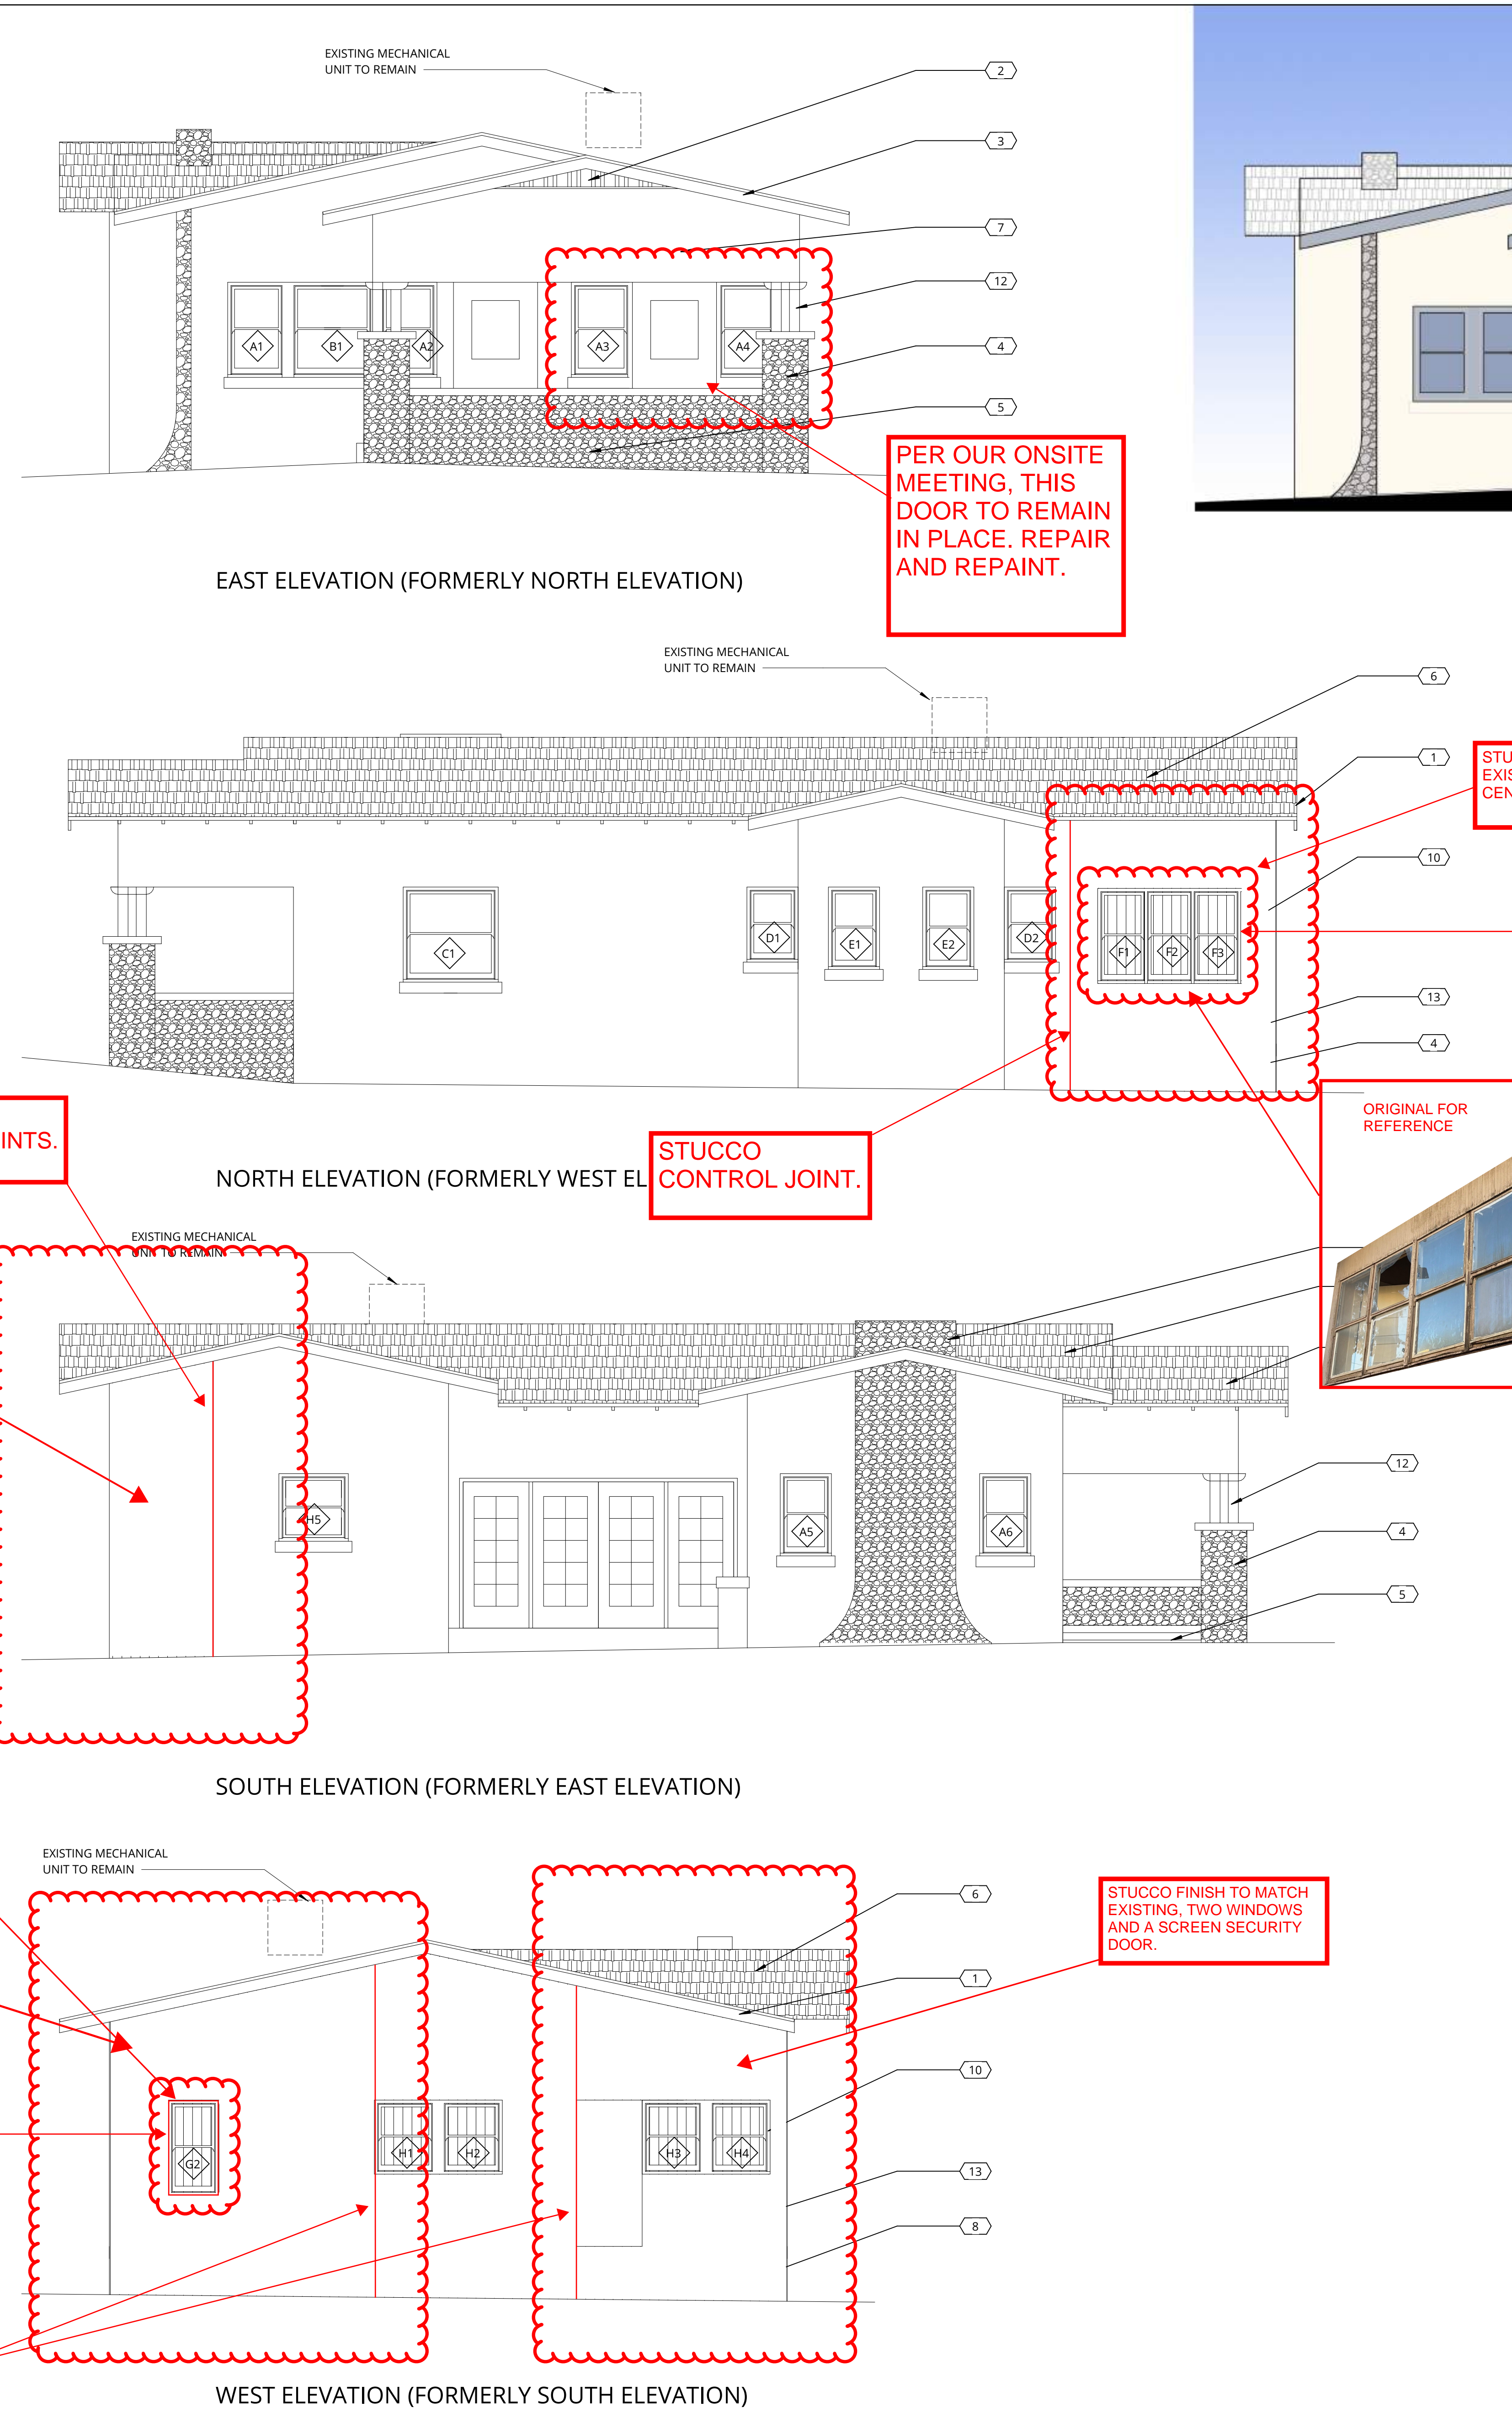
1 818 E SPEEDWAY - EXTERIOR ELEVATIONS
1/4" = 1'-0"

Per the January 22, 2026 site walk, portions of the north elevation, a small section of the south elevation, and the west elevation of House 818 were originally shown to retain existing wood siding. Based on site observations, the existing wood siding in these areas was determined to be not salvageable due to severe water damage. As discussed onsite, these areas are proposed to be replaced with stucco to match the existing house, in order to maintain consistency and improve long-term durability.

As shown on the markup drawings, a revised window configuration is also proposed for House 818 to reflect the layout discussed during the site walk, while maintaining appropriate proportions and alignment consistent with the building's character.

Additionally, as shown on the markup drawings, the east elevation will remain unchanged. It was determined during the site walk that the second entry door on the east elevation is original, and therefore both entry doors are proposed to remain, with the original door to be repaired and restored. These requested changes are limited solely to House 818. No other properties or exterior elements are impacted beyond what is described herein.

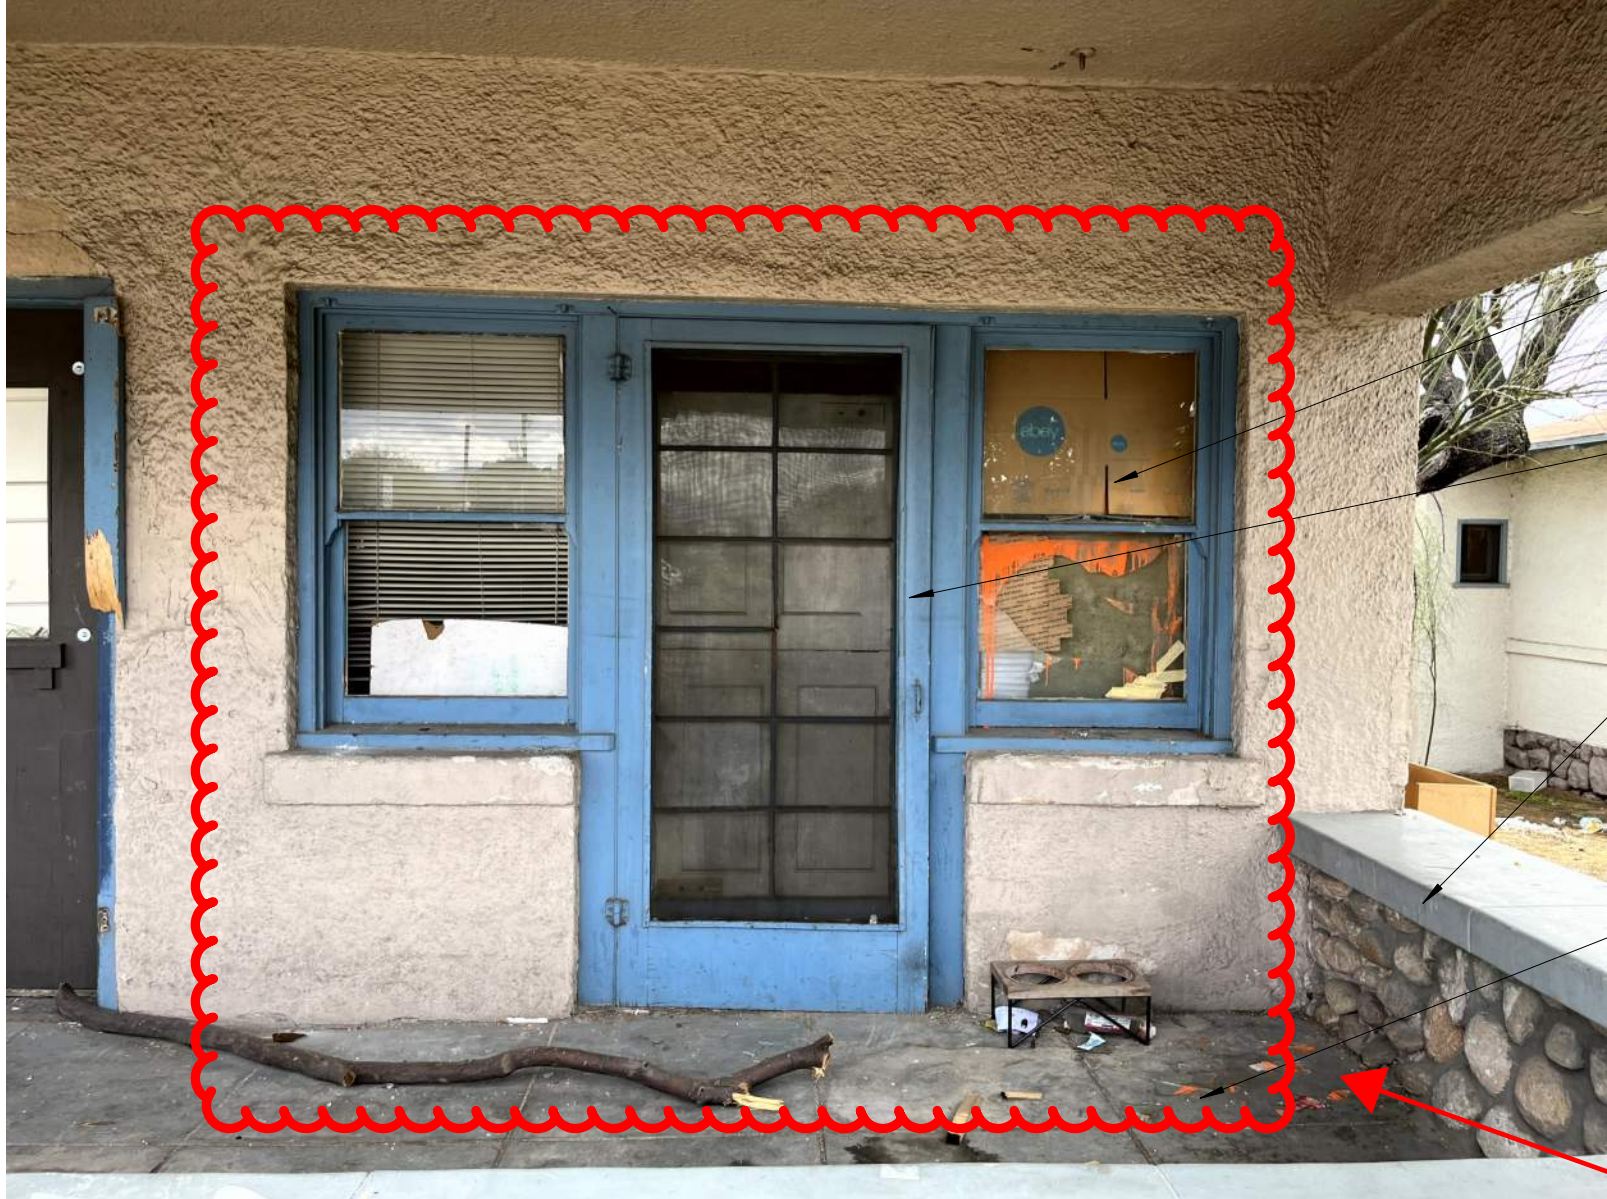
EAST ELEVATION (FORMERLY NORTH ELEVATION)

PER OUR ONSITE MEETING, THIS DOOR TO REMAIN IN PLACE. REPAIR AND REPAINT.

- BROKEN GLASS TO BE REPLACED. SEE PLANS AND WINDOW SCHEDULE FOR LOCATIONS.
- NON-ORIGINAL DOOR TO BE DEMOLISHED AND REPLACED WITH WINDOW TO RESTORE ORIGINAL CONDITION. SEE ELEVATIONS.
- PARTIAL HEIGHT COBBLESTONE PORCH WALL TO BE DECONSTRUCTED, SALVAGED AND RECONSTRUCTED AT NEW LOCATION.
- NEW CONCRETE FLOOR SLAB TO MATCH EXISTING FOR COLOR, TEXTURE AND SCORING PATTERN.

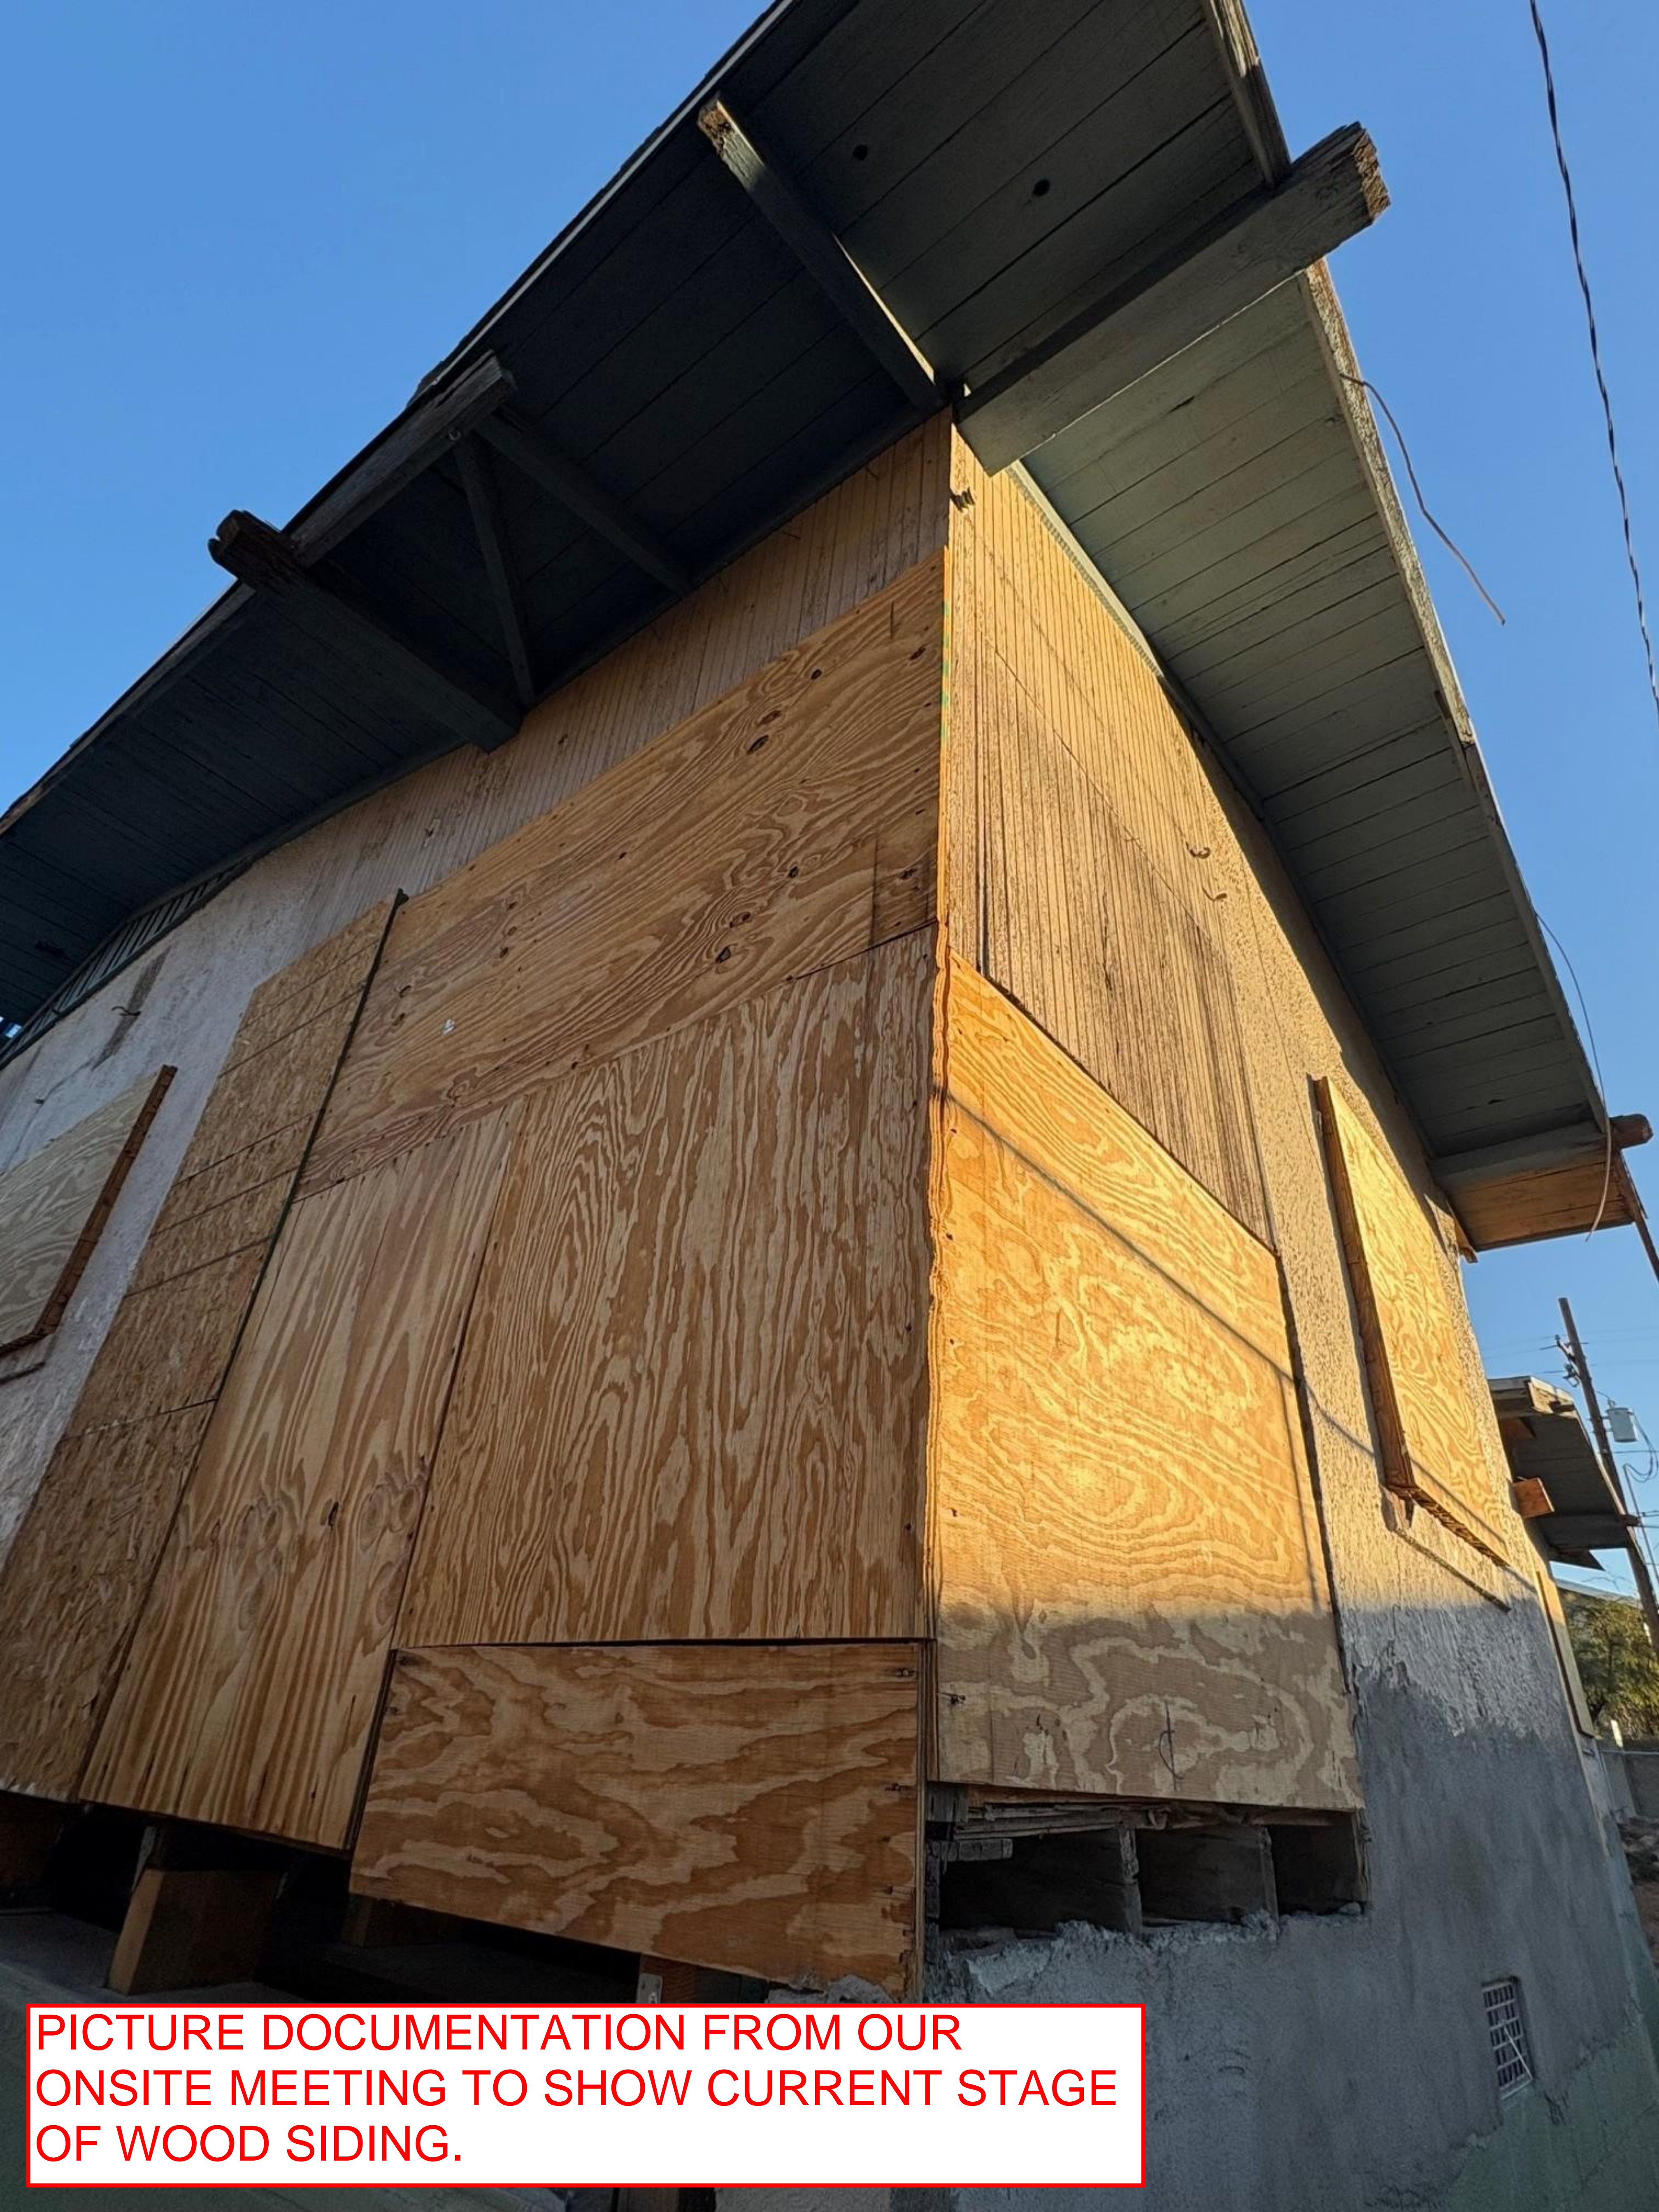
PICTURE DOCUMENTATION
FROM OUR ONSITE MEETING
TO SHOW CURRENT STAGE
OF WOOD SIDING.

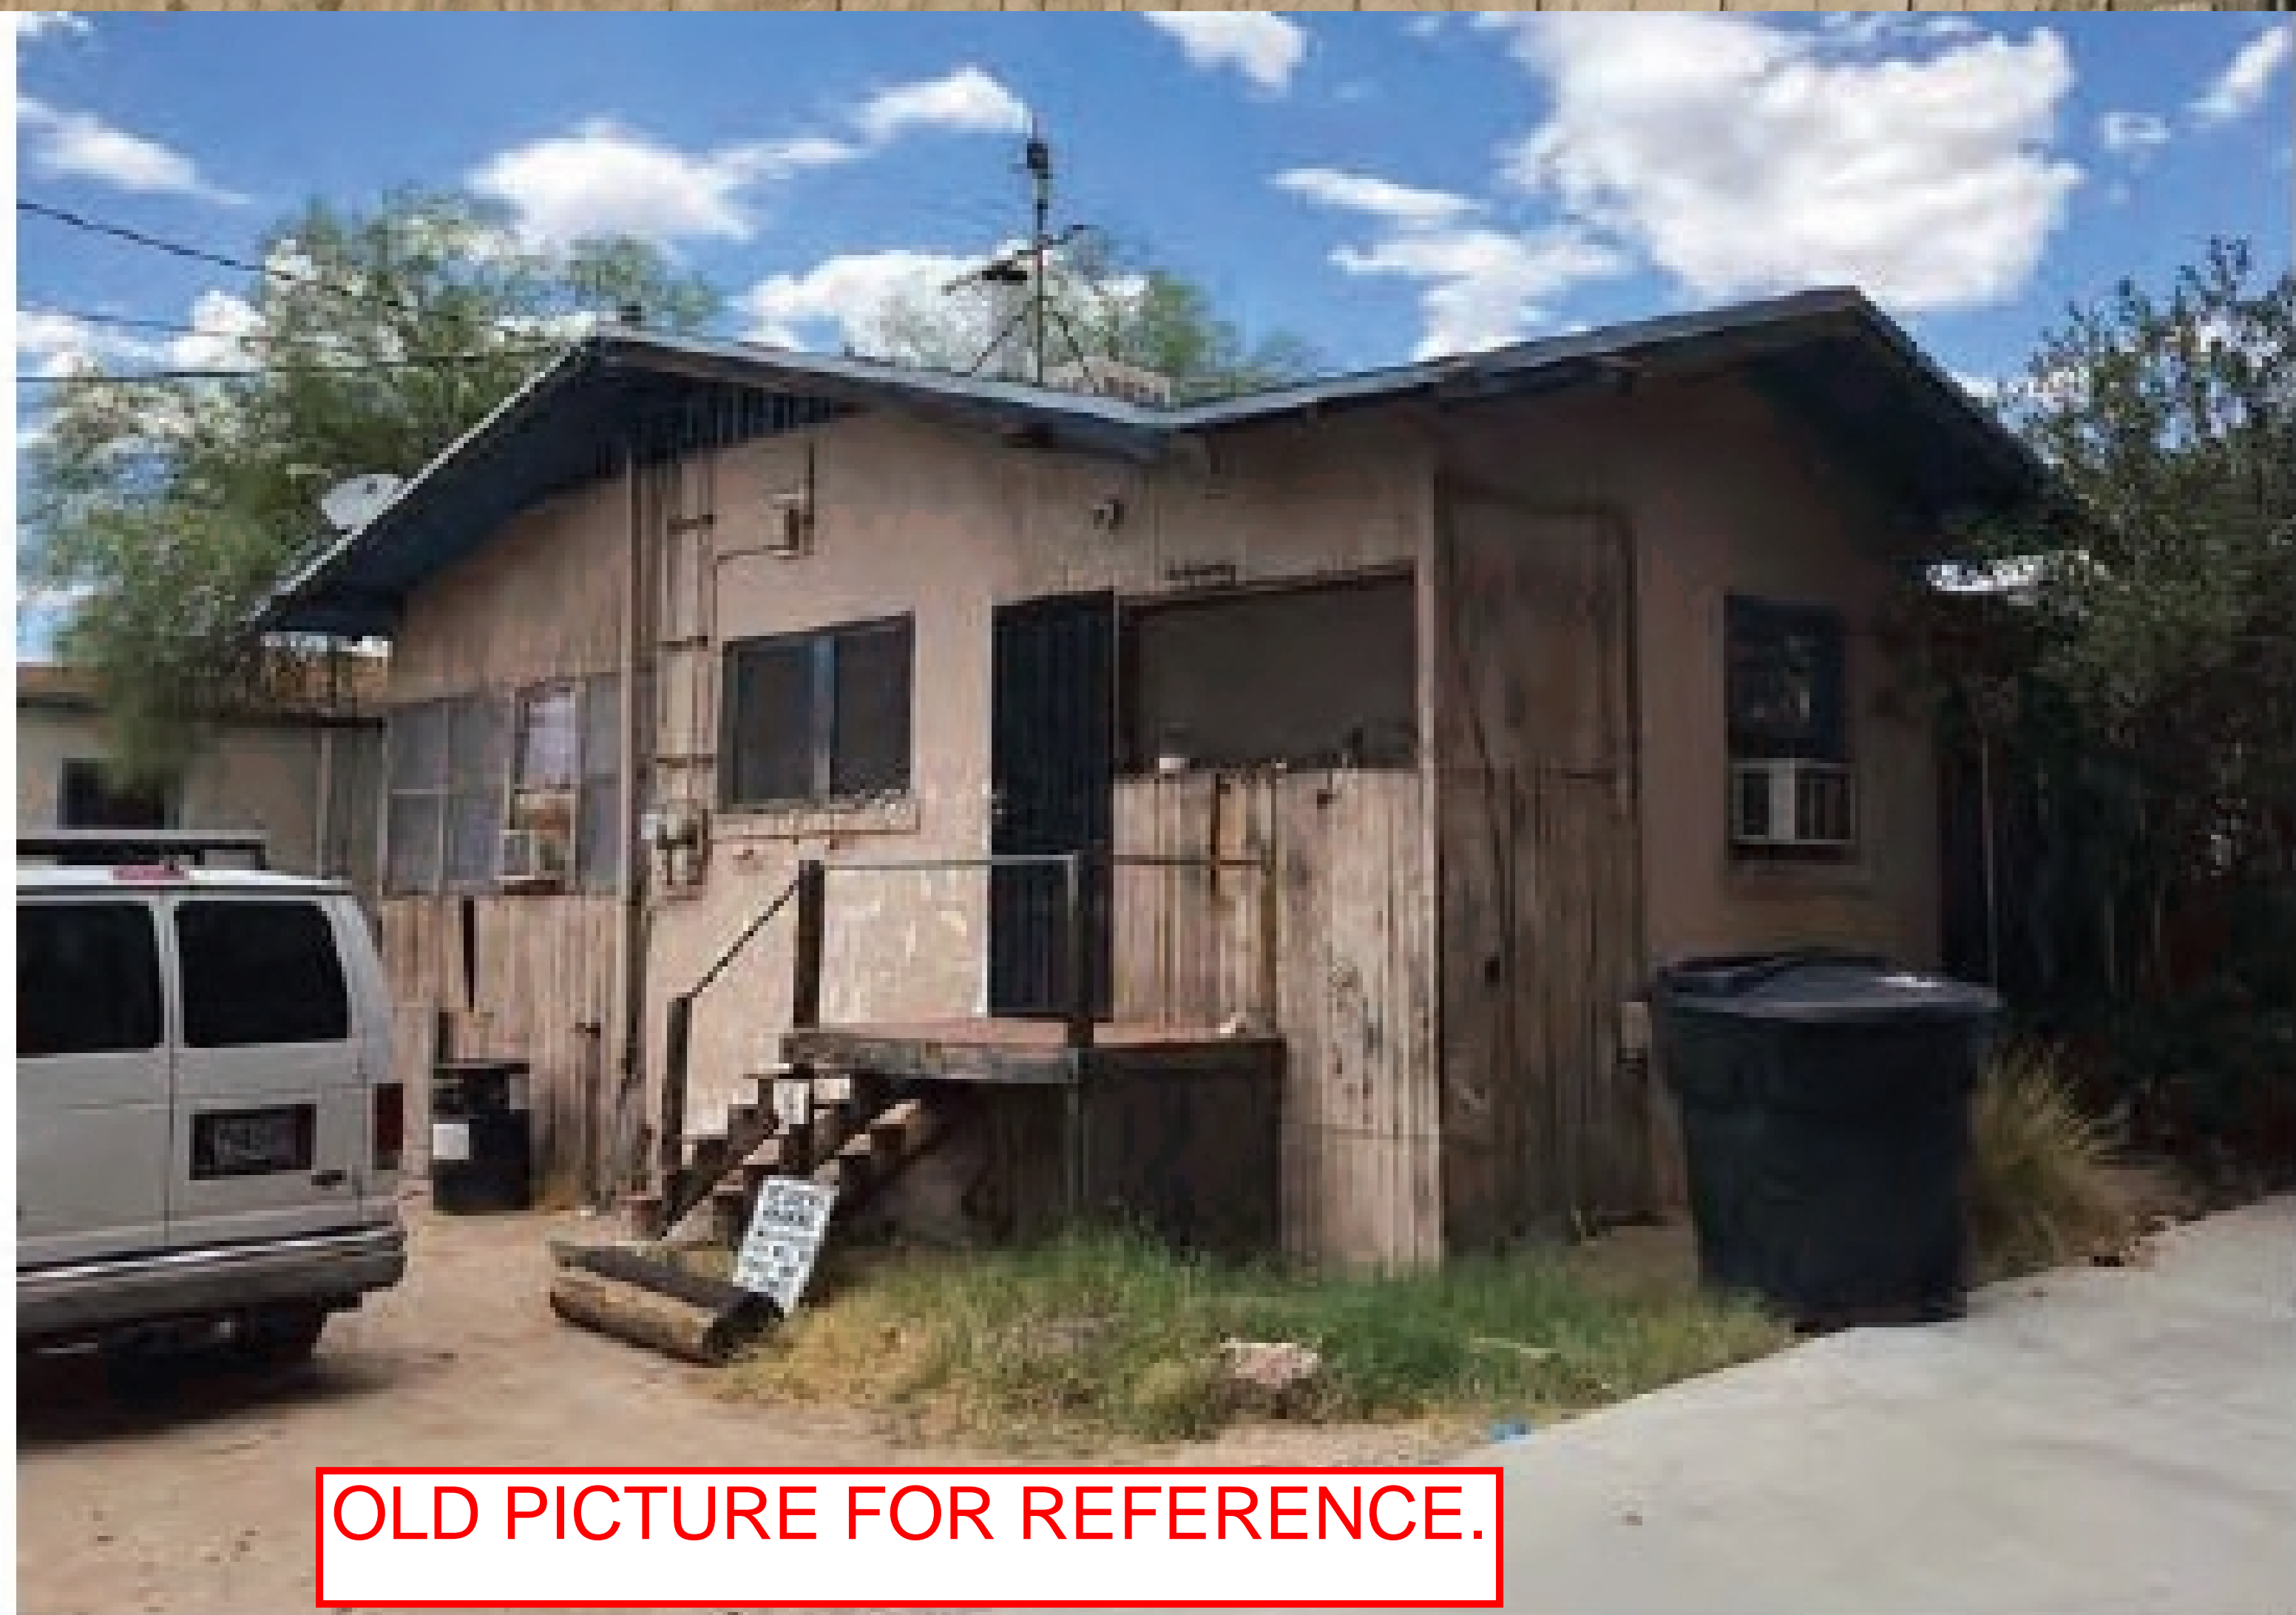
OLD PICTURE FOR REFERENCE.
