From:Gabriel Vargas, PM
GGV Designs, PLLC**PDSD Activity Number:****TC-RES-1124-06890**Zona Investments LLC
306 S. 3rd Av.
Tucson, Arizona**HPZ Case Number:** TBD

Armory Park HPZ

Project Description:

The property is located on the southwest corner of 3rd street and 13th street. It is a single-family residence located in an HO-3 historic zone. The residence is a contributing structure to Armory Park Historic Residential District. According to the assessor's record, the existing structure was constructed in 1893. The construction consists of a traditional raised wood framed floor set on a rubble stone foundation. The exterior walls are constructed of raw adobe mass walls over the exposed rubble foundation, with a plaster finish. The roof structure is composed of nominal lumber that bears at the exterior walls, with supports from some of the interior mass walls. The roof has a pitch of approximately 7:12 pitch and is currently finished with asphalt shingles.

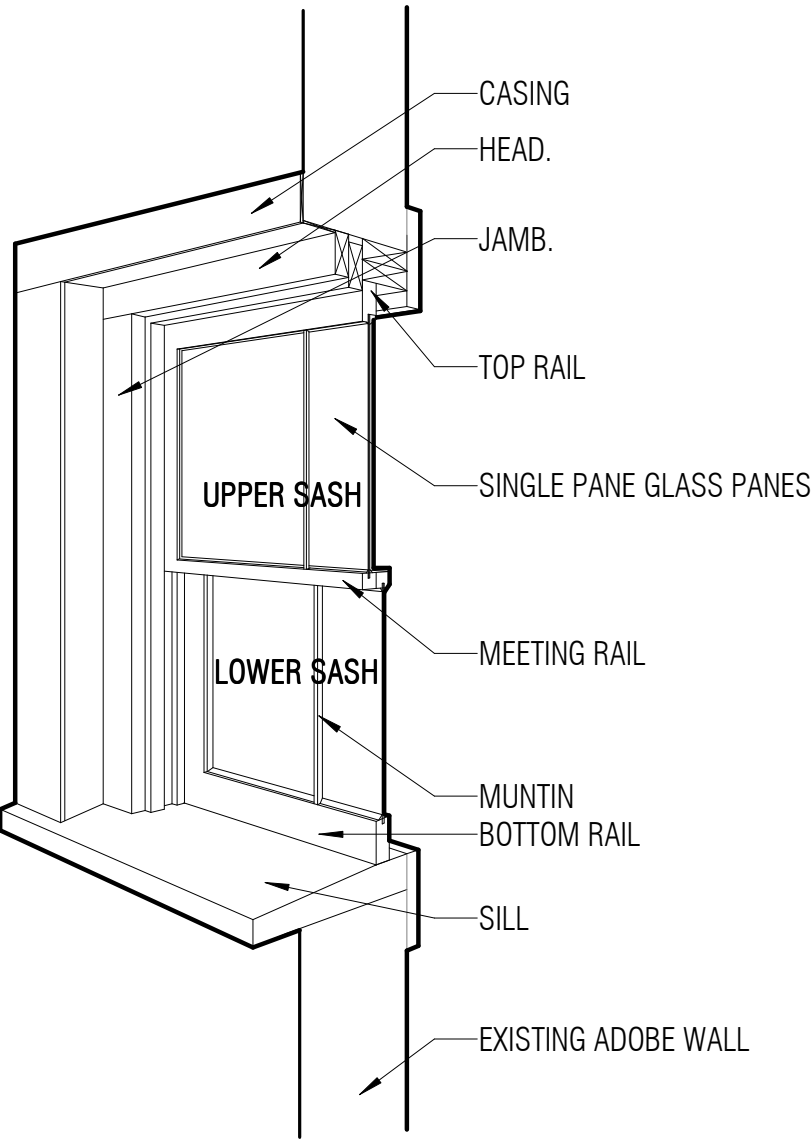
3 WINDOW REPAIR DETAIL TYPE 1
1/2" = 1'-0"

- NOTES:
- REMOVE DANGED DETERIORATED PAINT / LACQUER TO THE NEXT SOUND LAYER USING THE GENTLEST METHOD POSSIBLE. METHODS OF REMOVAL SHALL CONFORM WITH THE GUIDELINES FOR REHABILITATING HISTORIC BUILDINGS.
 - REPLACE DAMAGE GLASS PANE ON LOWER SASH
 - FABRICATE MISSING LOWER SASH TO MATCH EXISTING. FABRICATION SHALL CONFORM WITH THE GUIDELINES FOR REHABILITATING HISTORIC BUILDINGS.
 - REPAIR DAMAGED PULLY AND OR SASH CORD FOR FULLY FUNCTIONAL OPERATION
 - CAULK AND REPLACE SEALS AS NEEDED.
 - REPLACE NON CONFORMING WINDOW AND ADD MISSING UPPER AND LOWER SASH IN EXISTING CASING.
 - USE OBSCURED GLASS.

- Windows and doors shall be repaired and restored. There is one window and one door that is non-conforming to the original construction. The non-conforming window was added within the inside of the original window frame where both sashes were removed. The restoration shall comply with *Guidelines for Rehabilitating Historic Buildings; Building Exterior Wood*.

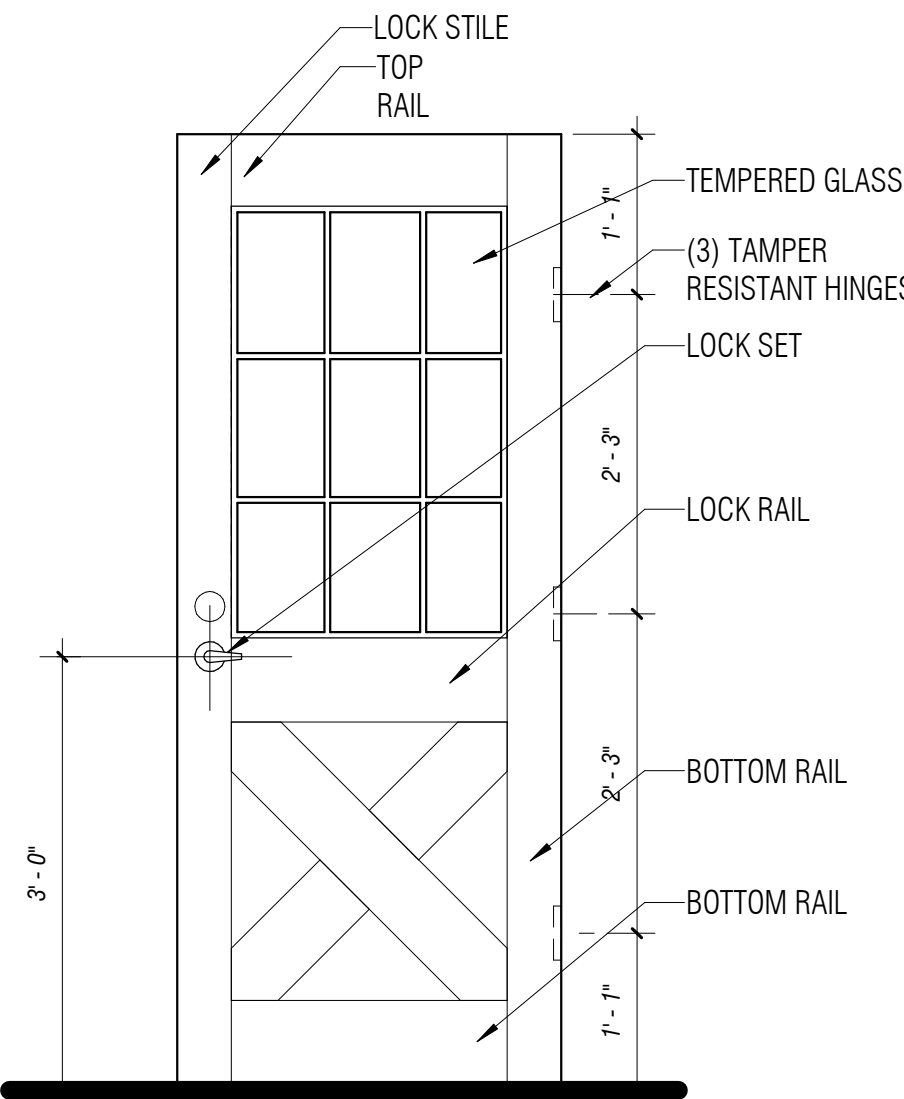
2 DOOR DETAIL
3/4" = 1'-0"

- NOTES:
- REMOVE DANGED DETERIORATED PAINT / LACQUER TO THE NEXT SOUND LAYER USING THE GENTLEST METHOD POSSIBLE. METHODS OF REMOVAL SHALL CONFORM WITH THE GUIDELINES FOR REHABILITATING HISTORIC BUILDINGS.
 - REPAIR LOCK STILE OF DOOR. METHODS SHALL CONFORM WITH THE GUIDELINES FOR REHABILITATING HISTORIC BUILDINGS.
 - REPLACE EXISTING NON CONFORMING DOOR WITH CUSTOM FABRICATED WOOD DOOR TO MATCH DOOR 104. FINISH SHALL MATCH EXISTING.
 - REPLACE NON CONFORMING LOCKSET WITH HISTORICALLY APPROPRIATE HARDWARE. VISIT WWW.VANDYKES.COM

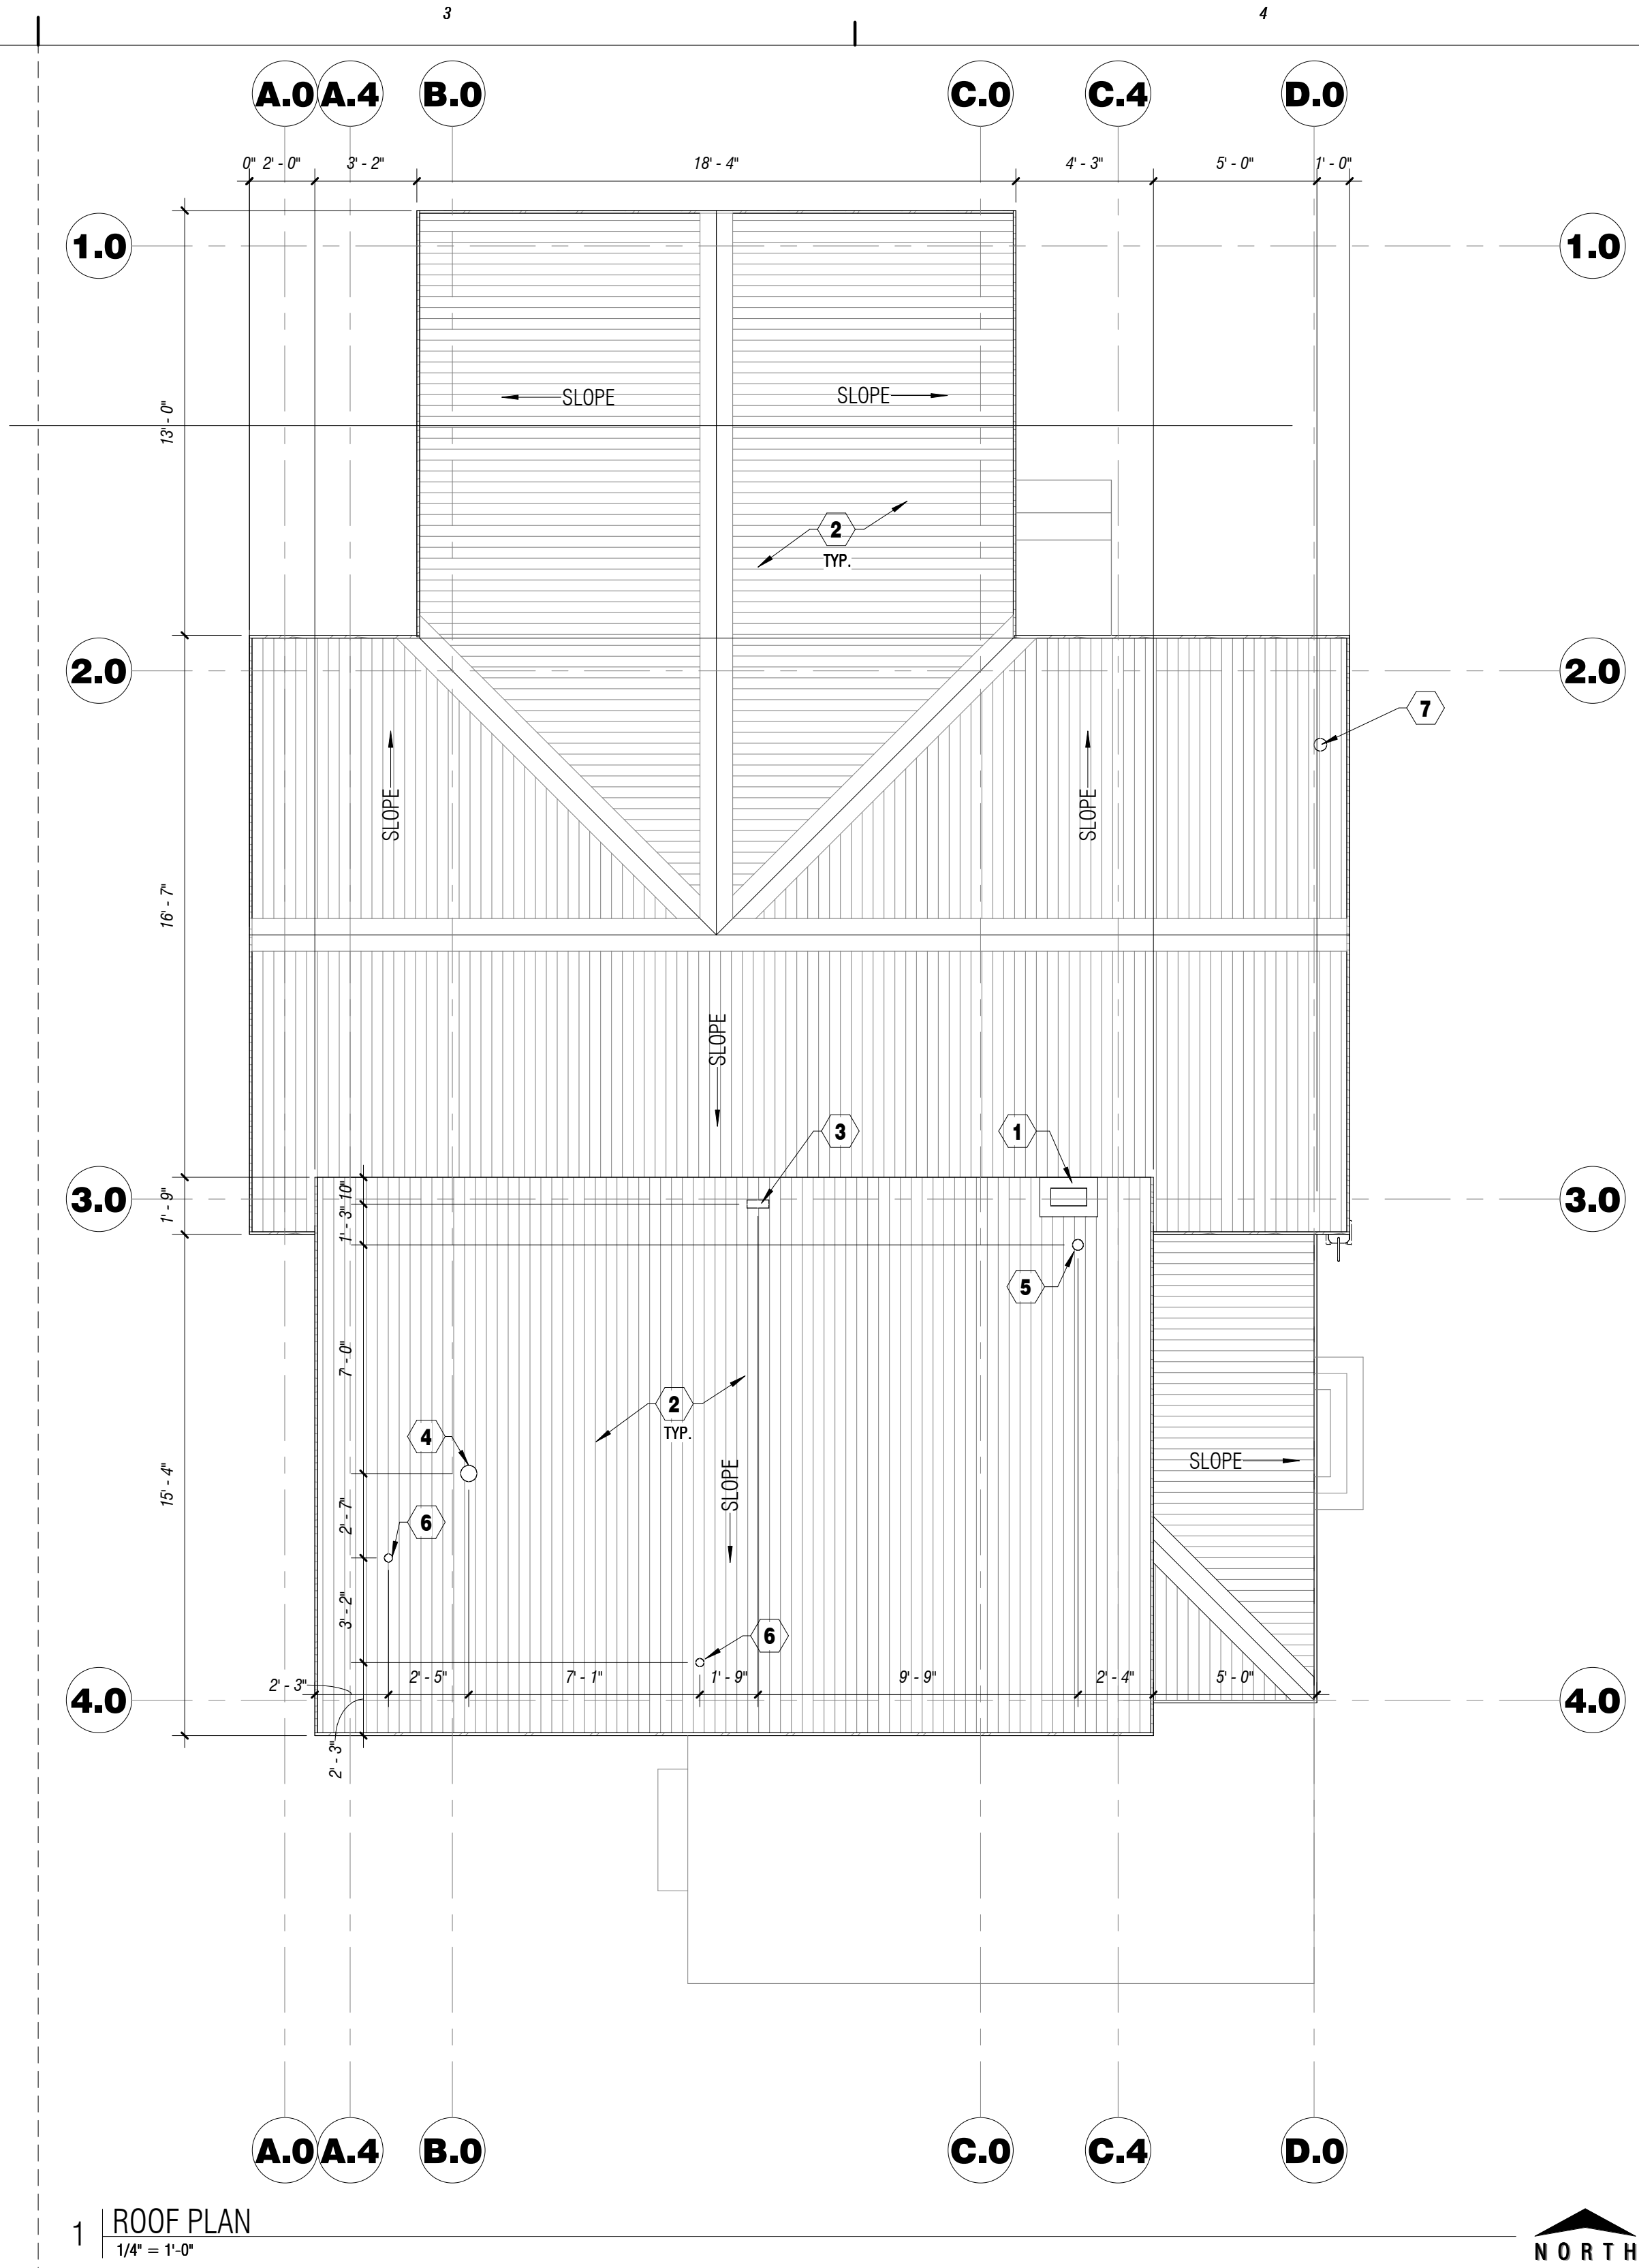
1 | ROOF PLAN
1/4" = 1'-0"

- UNDERLAYMENT SHALL HAVE END LAPS (TOP AND SIDE) OF A MINIMUM OF 4", SIDE AND OFFSETS BY 6'-0".
- UNDERLAYMENT SHALL BE ATTACHED WITH CORROSION-RESISTANT FASTENERS IN A GRID PATTERN OF 12" BETWEEN SIDE LAPS WITH A 6" SPACING AT TOP AND SIDE LAPS.

TYPE: CORRUGATED C-PANEL
BRAND: TBD APPROVED BY HOMEOWNER
MODEL: TBD APPROVED BY HOMEOWNER
COLOR: TBD APPROVED BY HOMEOWNER
UNDERLAYMENT: MOISTURE BARRIER OR PER MANUFACTURER RECOMMENDATIONS
LOCATION: ENTIRE ROOF

- NOTES:
- INSTALL PER MANUFACTURERS RECOMMENDATIONS.
 - HOMEOWNER SHALL SELECT COLOR OF FINISH AND PRODUCT.
 - MANUFACTURER AND ROOF TYPE MAY BE SUBSTITUTED WITH EQUAL PRODUCT OR ACCEPTABLE ALTERNATIVE SYSTEM.
